HONTEK HC05XP1 VS. 3M TAPES

COMPARISON OF HYDROLYSIS RESISTANCE AND OTHERS

A White Paper, July 7, 2010

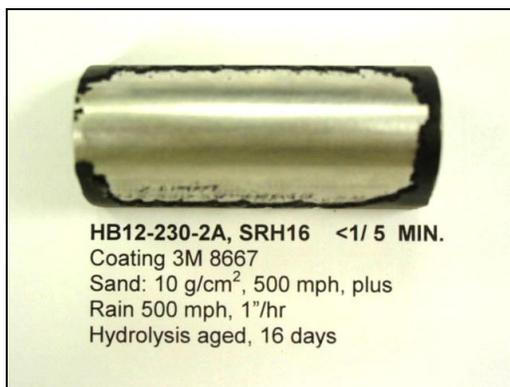
Hydrolysis-aged 3M 8667 after 5 minutes of rain.

3M 8663 tape is 0.020” thick and 8667 tape is 0.027” thick. **Both tapes were eroded to the substrate within one minute.** The photos below show the appearance after rain erosion for 5 minutes. As seen in the two photos below, there was nothing left on the leading edge after 5 minutes of rain test.

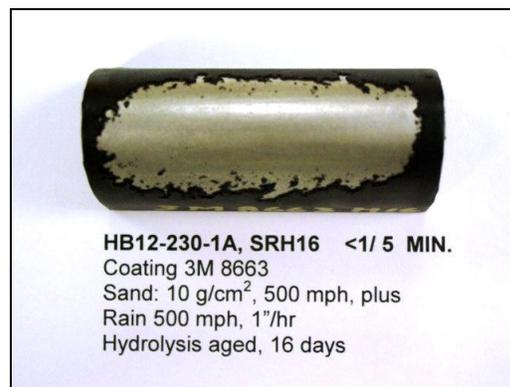
Hydrolysis-aged 3M 8663 after 5 minutes of rain.

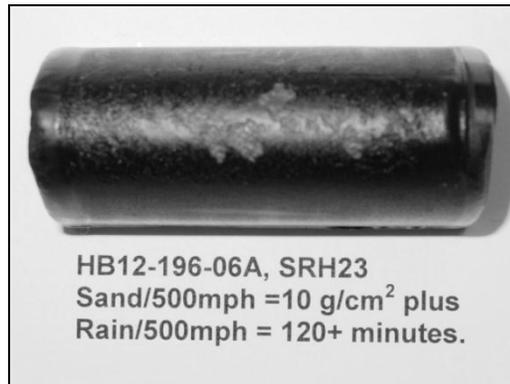
As seen in the photo below, the hydrolysis aged HC05XP1 sample performed well under the combined sand and rain test. **After sand erosion, it survived 120 minutes of additional rain erosion with only minor surface damage. HC05XP1 is more than 120 times better than 3M tapes!**

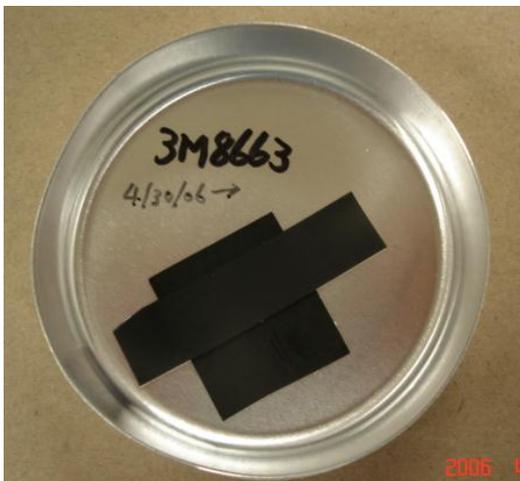
Above: Before hydrolysis aging
Clean edges of tape

After 15 days of hydrolysis aging, 3M 8663 tape can be easily broken into pieces and smeared around with a weak wooden toothpick. This shows that a true degradation and breakdown of the 3M tape has occurred (see photos below).

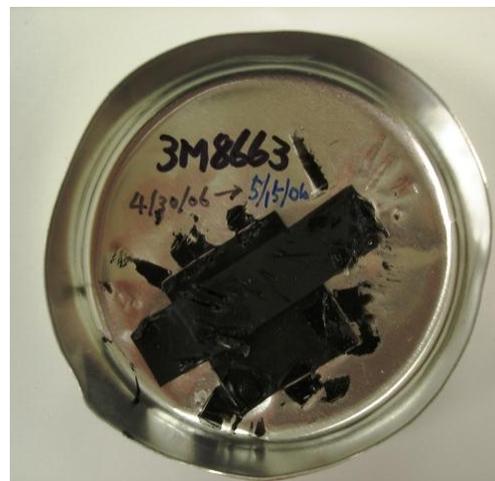
Above: After 15 days hydrolysis aging
Smeared edges of tape

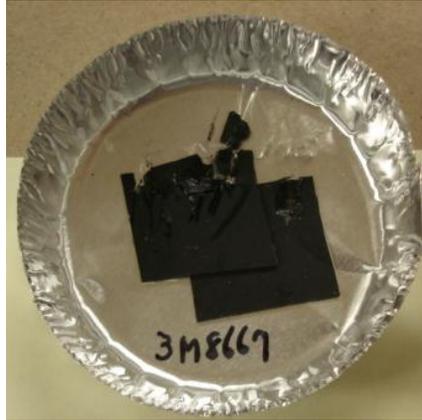
3M 8667 tape after 29 days of hydrolysis aging
Broken and smeared edge of tape

Similar degradation was observed on 3M 8667 tape when observed after 29 days of aging. Because these two tapes are of similar chemistry, it is likely that it was degraded in the same time frame as 3M 8663 tape. Note the tape was smeared with the use of a weak wooden toothpick.

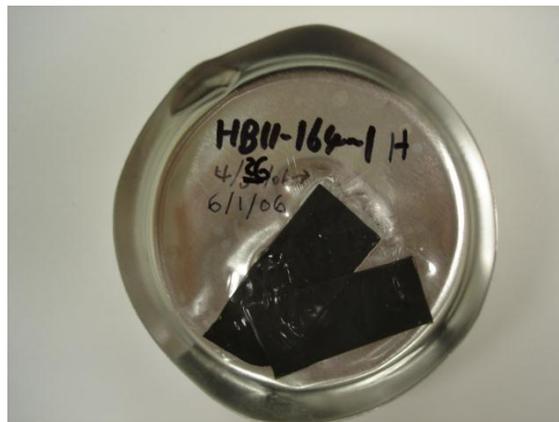
HC05XP1 (HB11-164-1) after 35 days of hydrolysis aging
Did not smear even after pushed/scraped with stainless steel spatula

After 35 days of hydrolysis aging, HC05XP1 softened at this extreme combination, but firmed up within one minute after removal from the oven. It remained strong and could not be broken or spread with a stainless steel spatula (much stronger than wood toothpick!). The photo below shows numerous indentation/push marks inside the coating that resisted the tearing force of the stainless steel spatula, but the coating did not smear like 3M tape. This shows that Hontek HC05XP1 has far superior hydrolysis stability than 3M tapes.

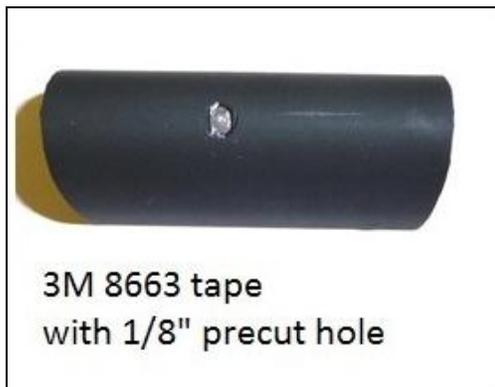
3M 8663 tape before rain erosion
Nice and clean

Two aluminum airfoils were covered with 3M 8663 tape and Hontek HC05XP1 coating. Using a razor blade, a 1/8" hole was created on the 3M 8663 airfoil, and a bigger 1/4" hole was created on the HC05XP1 airfoil. *Both were mounted on the same rain erosion test rig at the Wright-Patterson Air Force Base and tested side by side.* Rain test condition was 500 mph, one inch per hour rainfall, 1.8mm raindrop size.

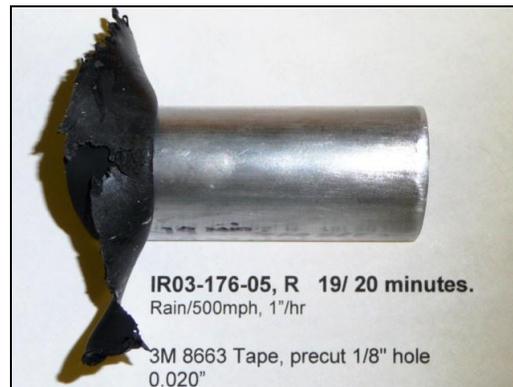
3M 8663 tape after 20 minutes in rain
Catastrophic delamination

Within 19 minutes, the 3M tape delaminated and was lifted off the aluminum airfoil substrate in large piece. [The photo below shows the 3M taped airfoil after 20 minutes of rain erosion.](#)

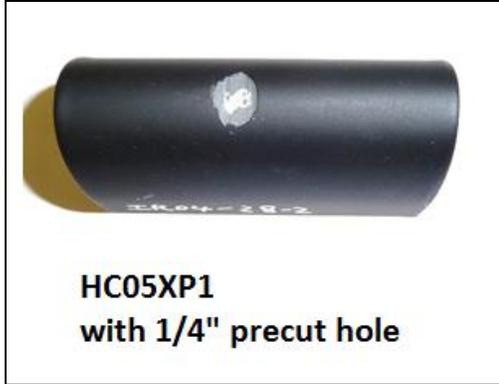
**HC06XP1 before rain
Nice and clean**

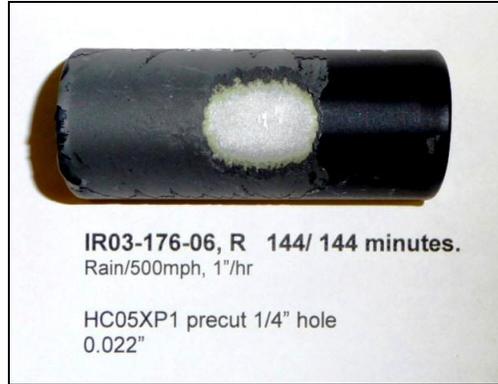
**HC05XP1 after 144 minutes rain erosion
Very slow damage site propagation**

With Hontek HC05XP1, even though the hole was twice as big as 3M tape, there was no delamination after 144 minutes. Part of the thin black topcoat layer was removed by the rain, but the basecoat continued to protect the substrate well. [At 144 minutes, the raindrops have already eaten into the aluminum surface, but HC05XP1 coating still showed only limited damage.](#)

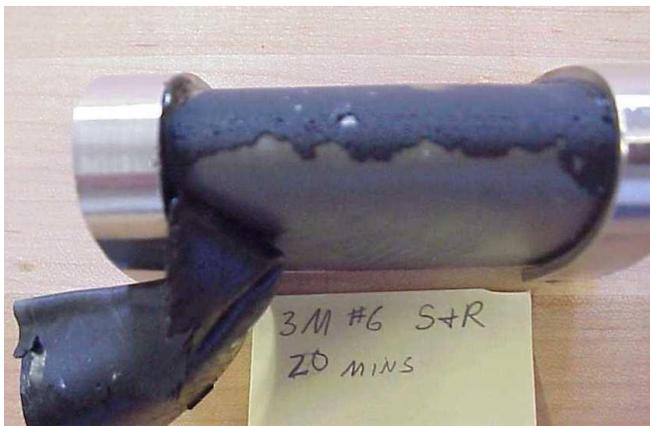
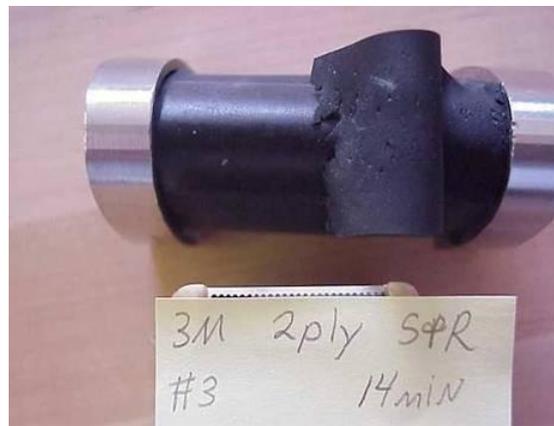
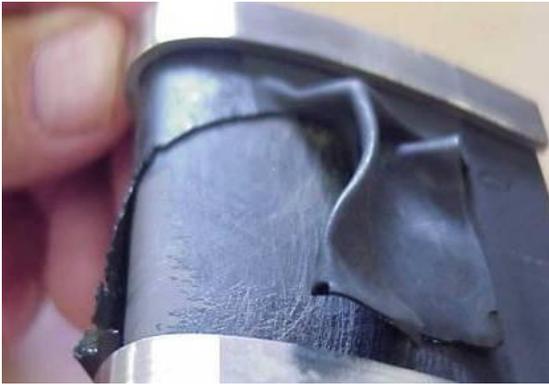
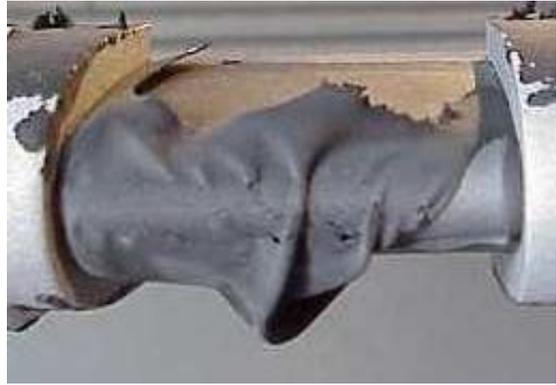
The following photos show the typical delamination observed in sand and rain erosion tests. Field experiences in UH-60 show that 3M tape requires repair every 3-20 flight hours. The sudden unexpected peeling of 3M tape caused severe vibration and grounding of the aircraft.

Lab erosion tests in combined sand and rain show that 3M tape typically eroded away in large pieces in 14-20 minutes.

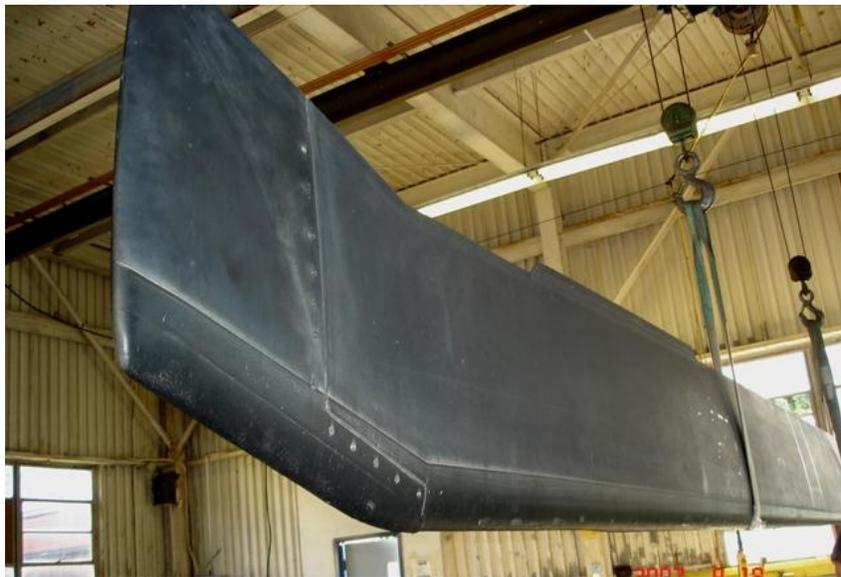
The following photo shows one of the blades returned to Sikorsky after serving 684 hours over one year in Iraq. The blades were in excellent condition. No track and balance issues even after repeated repairs in the field.

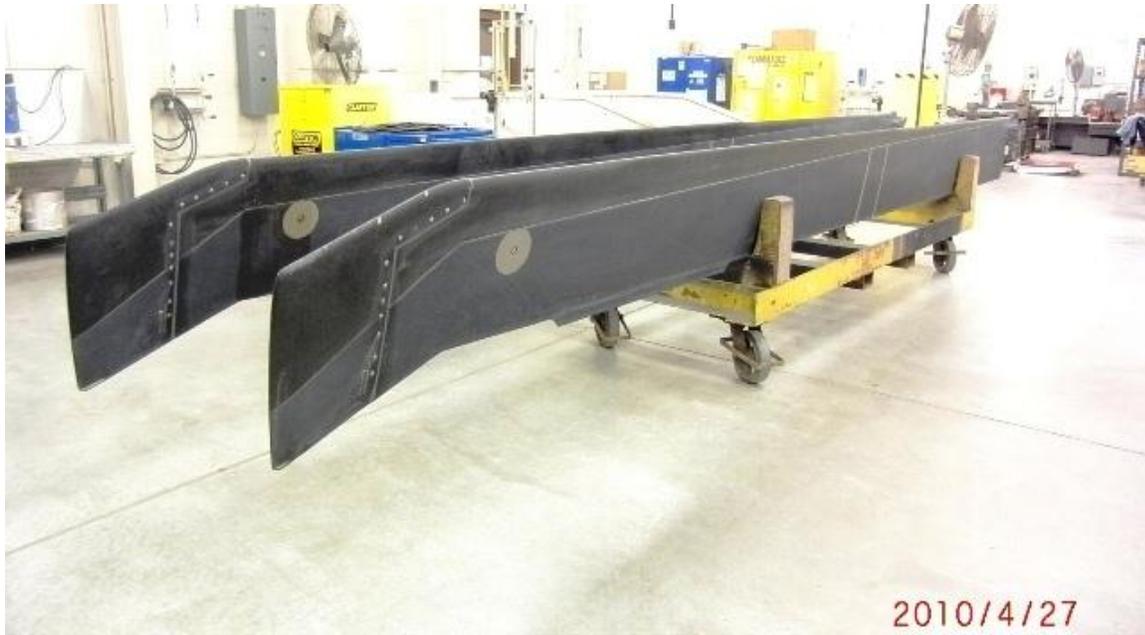
The following are blades returned after serving about 620 flight hours over one year in Afghanistan, with repairs done in the field. The blades are in excellent condition.

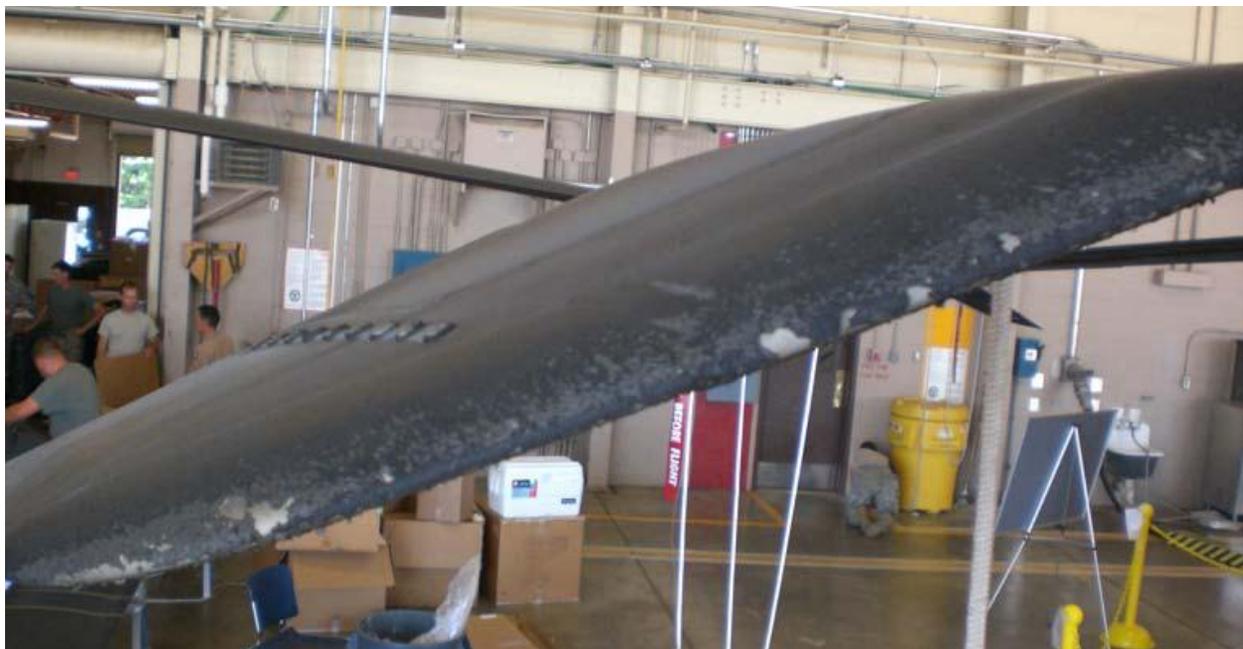
Hontek-coated blades do not delaminate like tapes. The following photo shows the average damages experienced after 100-120 flight hours in the theater, with combination of rain, sand and gravel impact damages. The damaged sites are isolated and small.

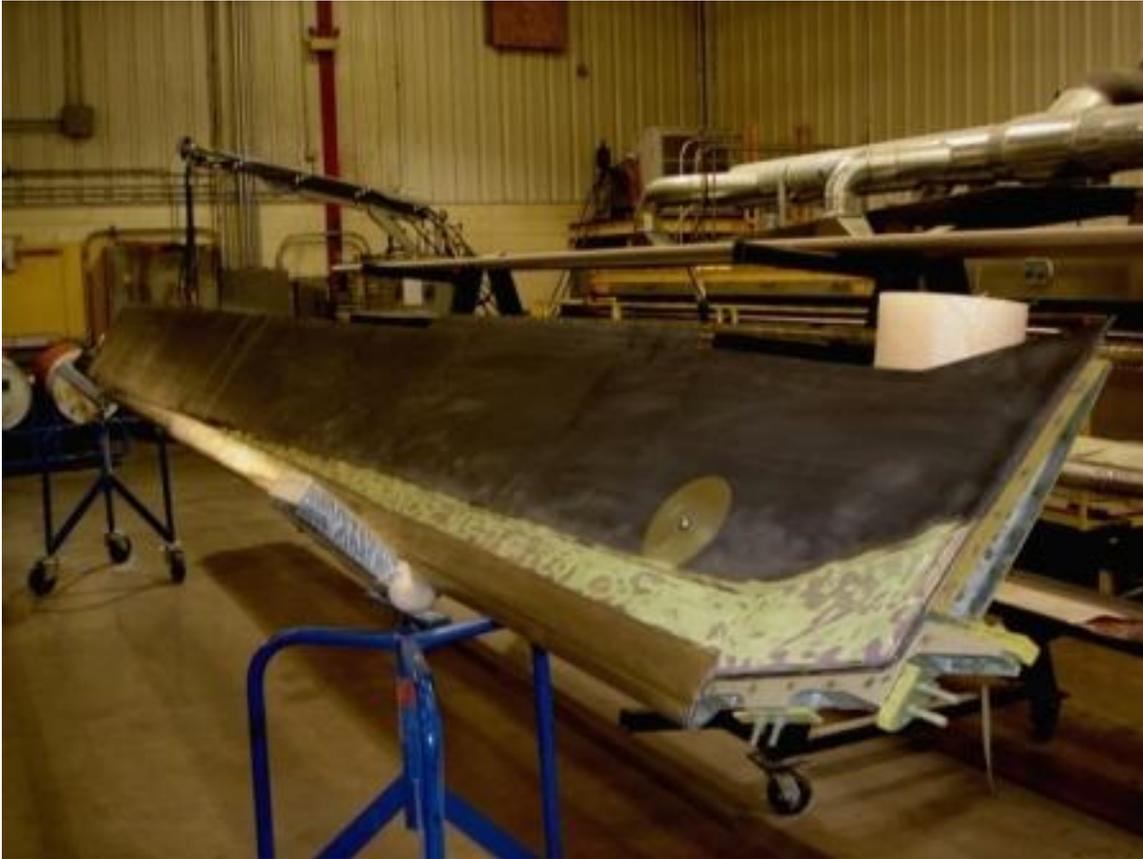
The following photo shows a stripped UH-60 blade with this process.

If for some reason the coating on the blades must be removed, it can be done efficiently with plastic media blasting and a combination of power sanding and hand sanding. Acrylic beads can strip the coatings on the metal substrate within second upon blasting. On the composite substrate, power sander is used to remove the sand erosion resistant topcoat layer and about 0.010” thick basecoat layer. Afterward, hand sanding is used to remove the remaining hand-sandable basecoat layer.
